Manhole Inspection Summary

Manhole # S45WW_008MH

Insp Date: **2/8/07 11:52 AM**

Location Address: **1847 29TH ST**

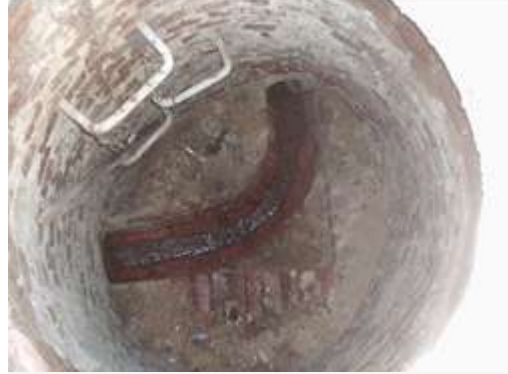
Top View

Bench debris.

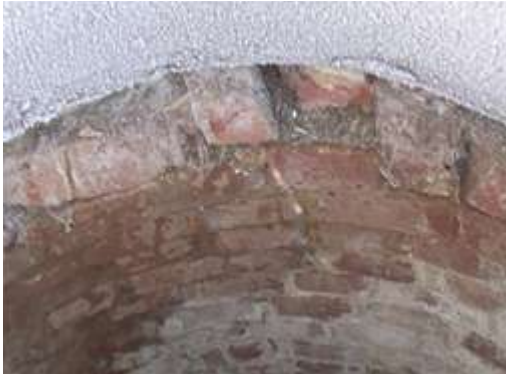
Defect

Frame leaks. Adjustment deterioration, loose brick and infiltration. Corbel infiltration.

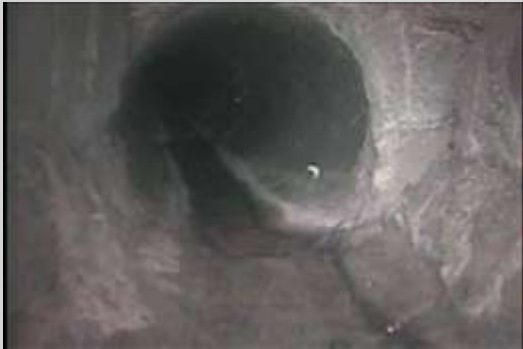
8 in. Circular Gravity Sewer Pipe Out @ 12 O'Clock

Invert Depth: **7.85** (ft.) Flow Characteristics: **Slow**

Deposits: ☒ None ☐ Mud ☐ Sludge ☐ Debris ☐ Grease

Infiltration: **None** Pipe Seal Cond: **Unknown**

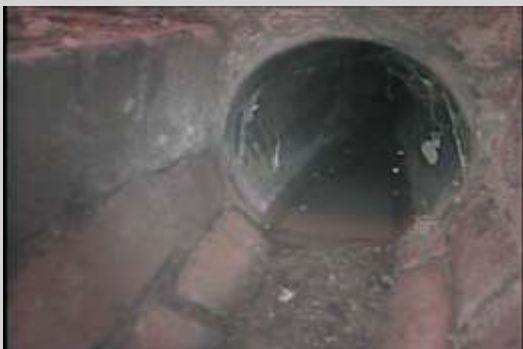
8 in. Circular Gravity Sewer Pipe In @ 9 O'Clock

Invert Depth: **7.64** (ft.) Flow Characteristics: **Slow**

Deposits: ☒ None ☐ Mud ☐ Sludge ☐ Debris ☐ Grease

Infiltration: **None** Pipe Seal Cond: **Unknown**
